# **Expedient Shelter Construction and Occupancy Experiments**

Cresson H. Kearny

**OAK RIDGE NATIONAL LABORATORY**

MARCH 1976

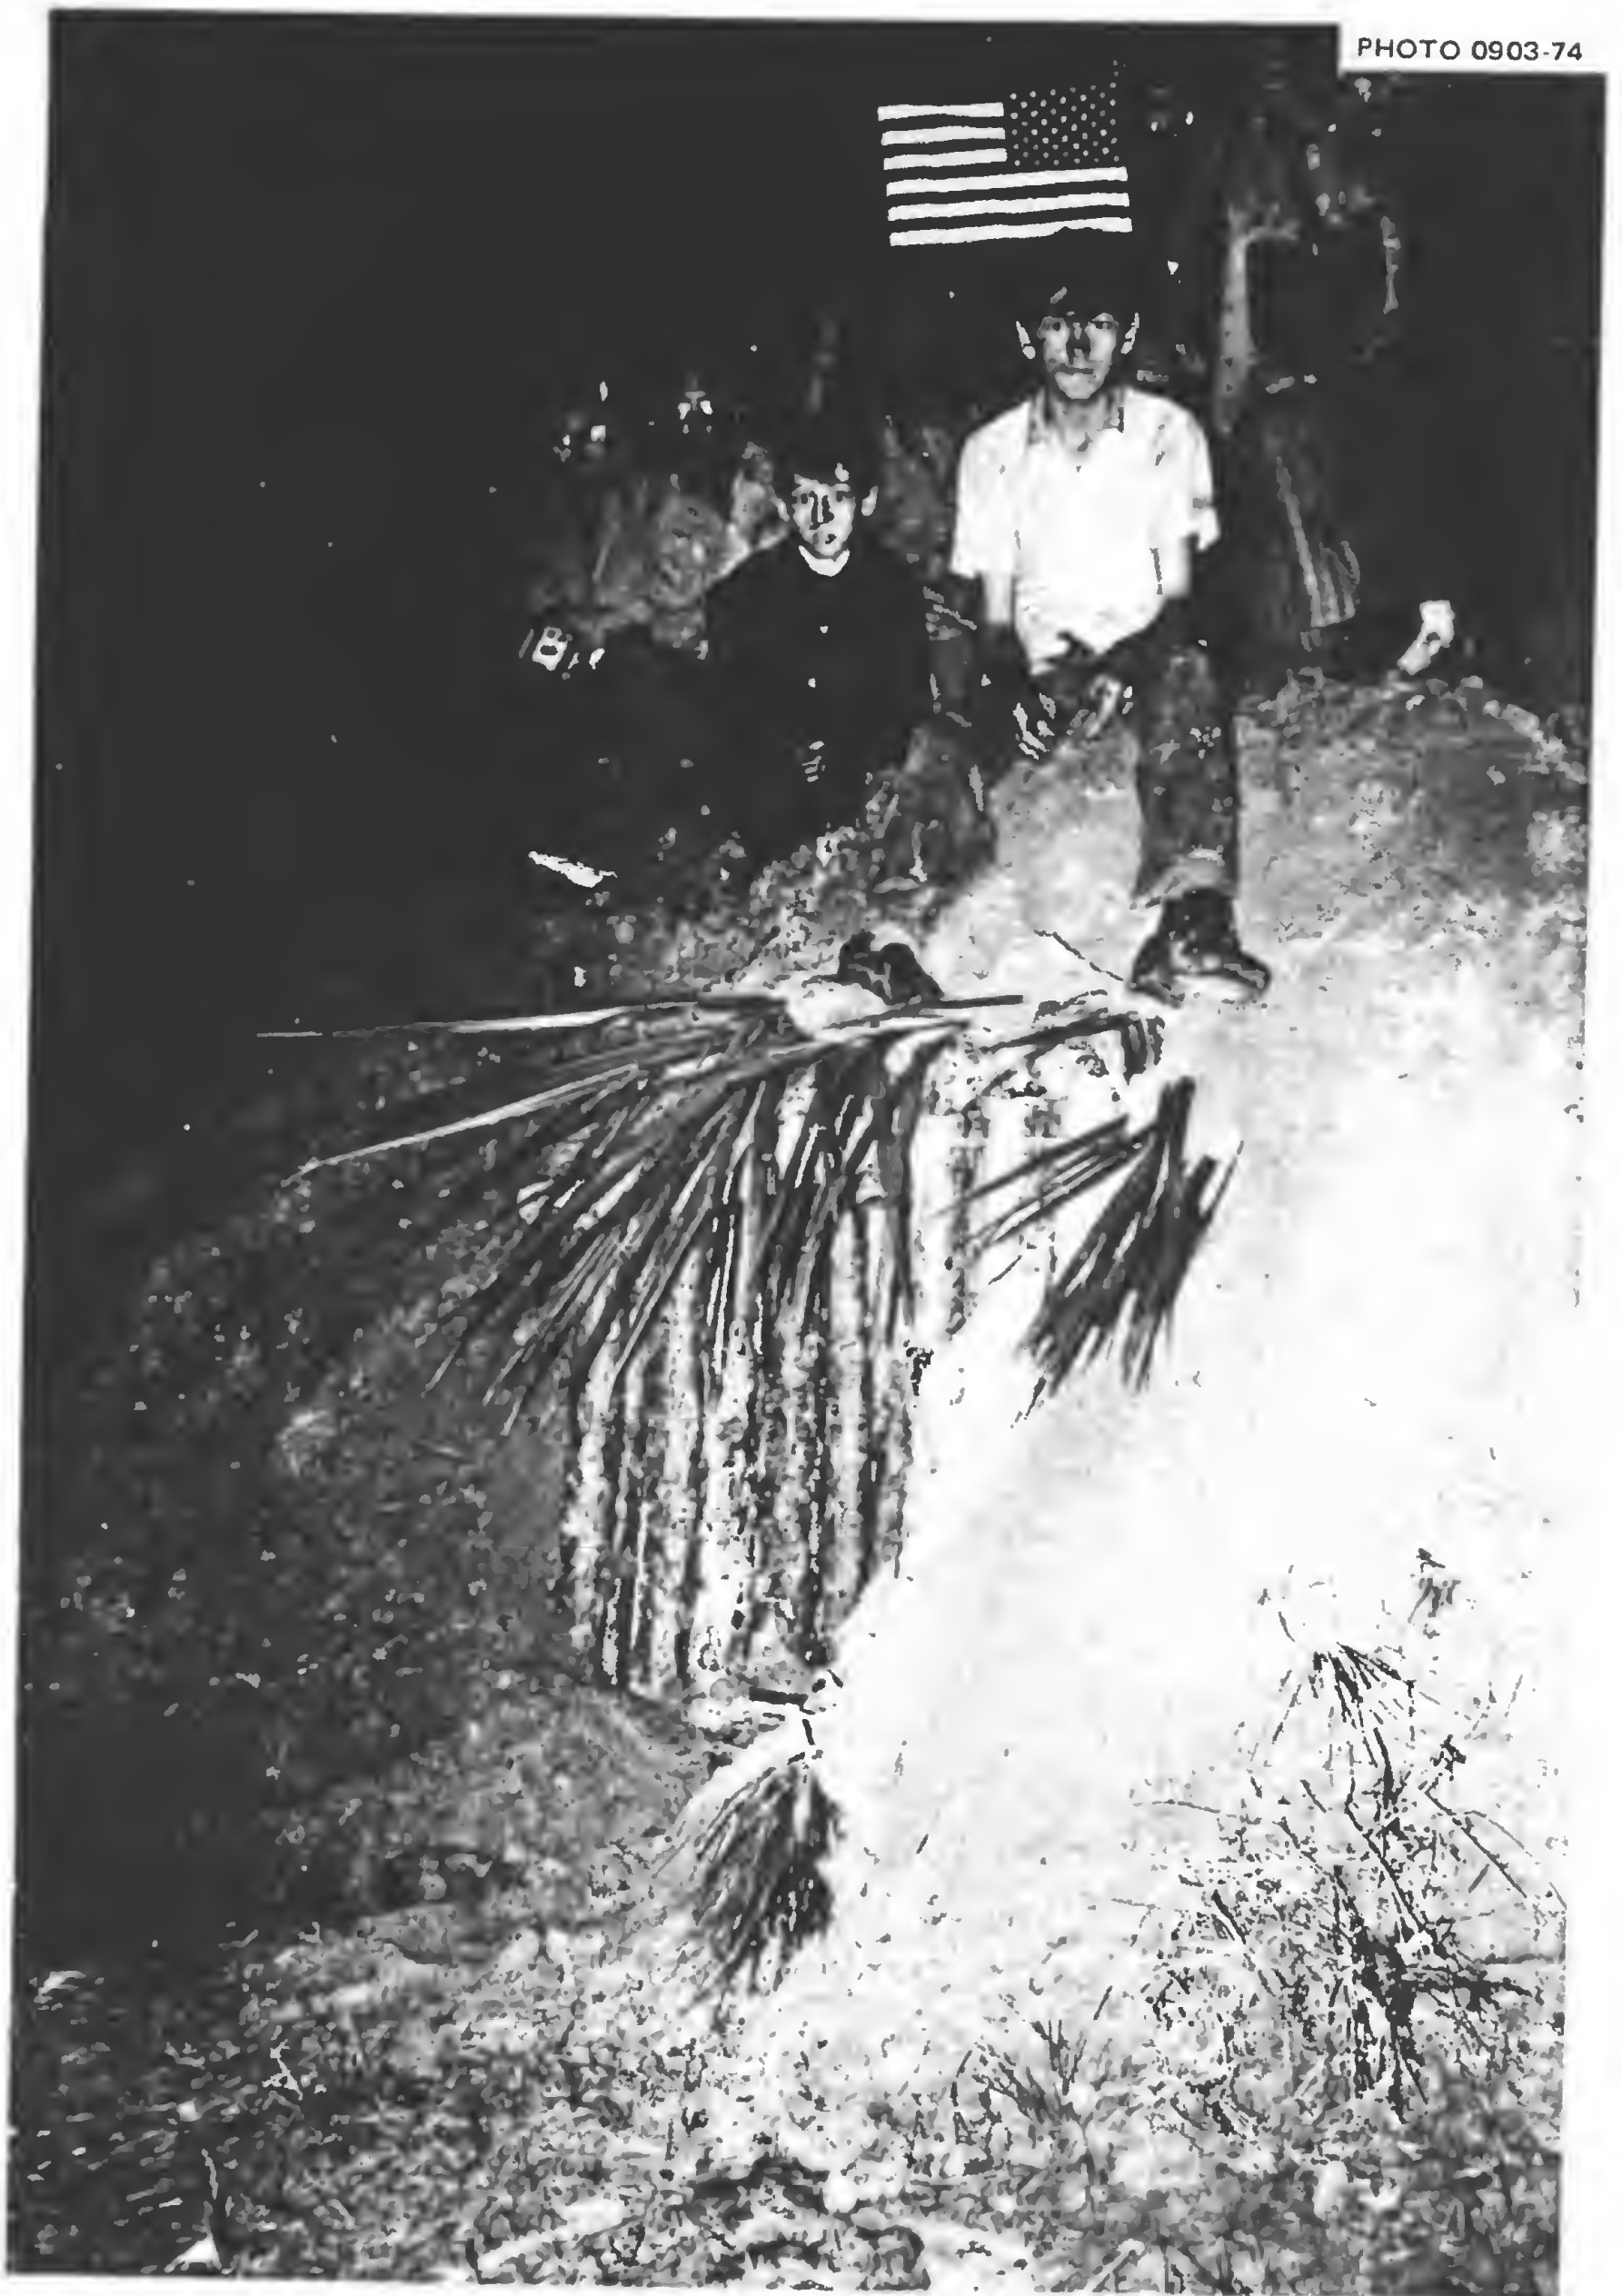
Fig. 5.37. The just-completed shelter at 6:40 AM, 23 hours and 40 minutes after the Walden families had been given the Evacuation Check List and the building instructions at their homes 12 miles away from the building site. Several of the adults worked essentially all night to complete this shelter in less than 24 hours, although they could have won the full bonus if they had completed it in 47 hours 59 minutes. They moved over 50 tons of earth by manual labor. The earth over the sheet-covered limbs across the wall poles was a full 2 ft thick.

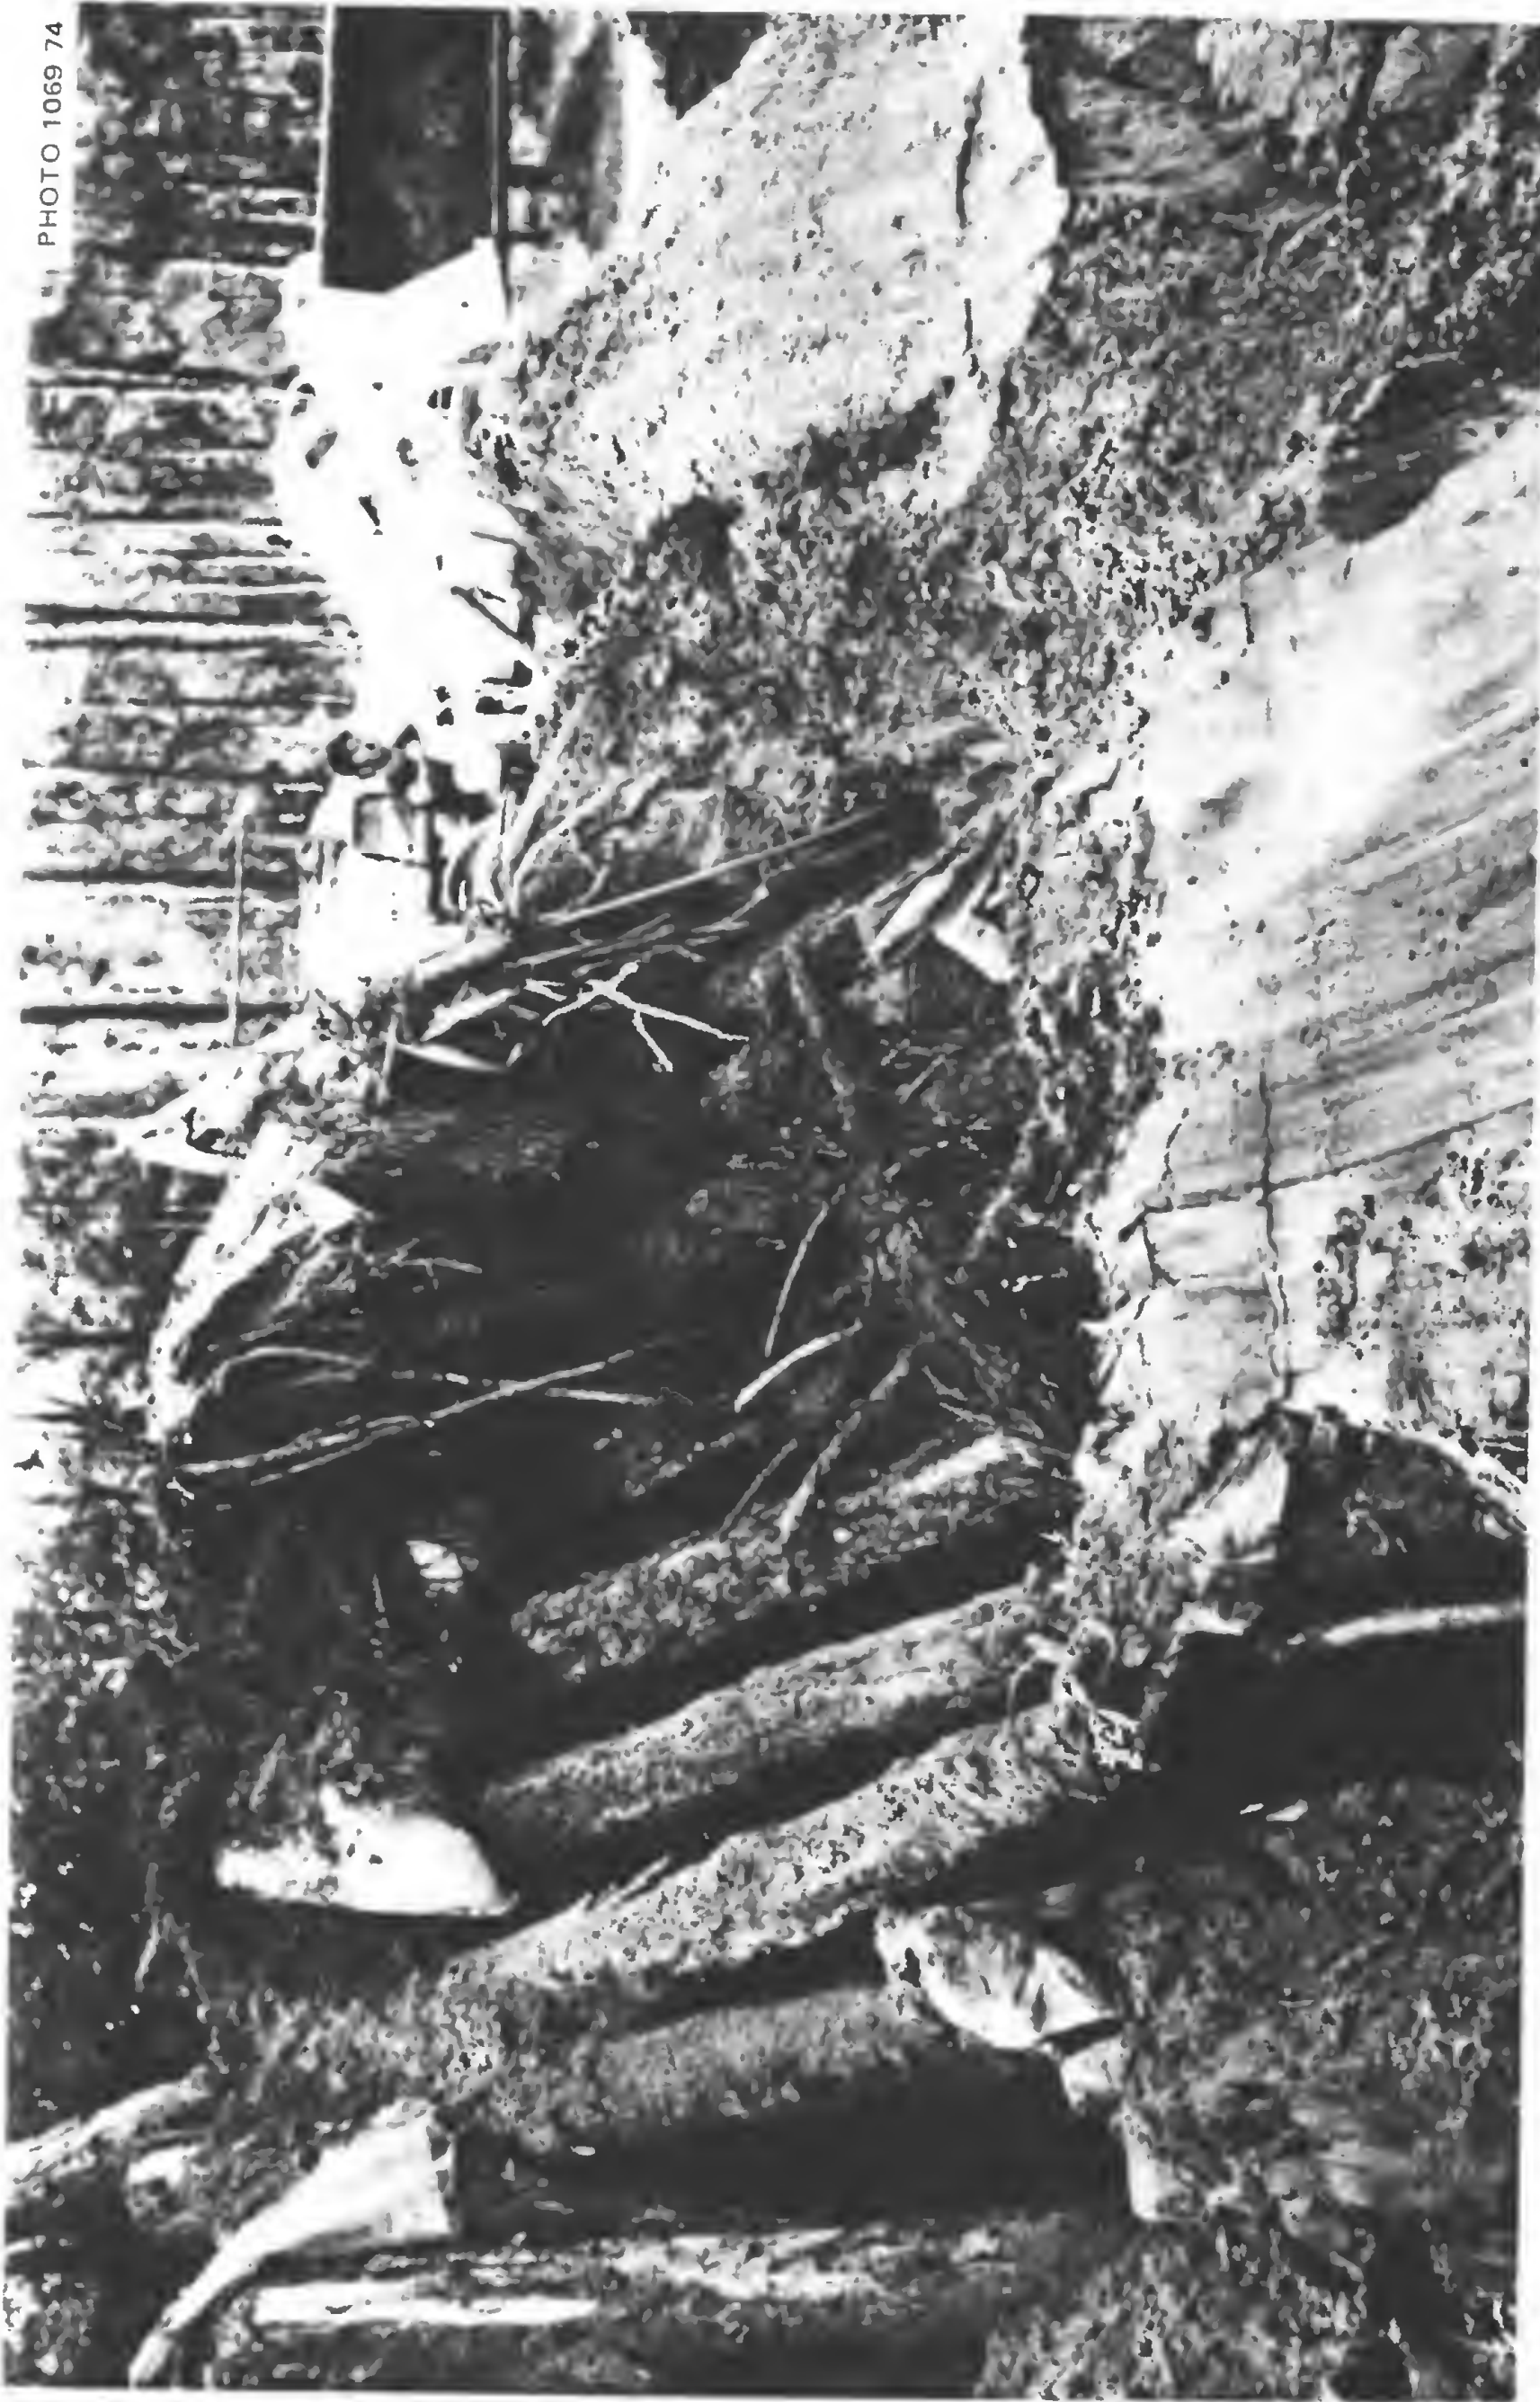
Fig. 5.40. View after a backhoe had started to demolish the Waldens' Ridge-Pole Shelter, which proved to be decidedly sturdy. Note that some of the wall poles were broken before they were moved off the ridge poles, or the ridge pole had been moved significantly.

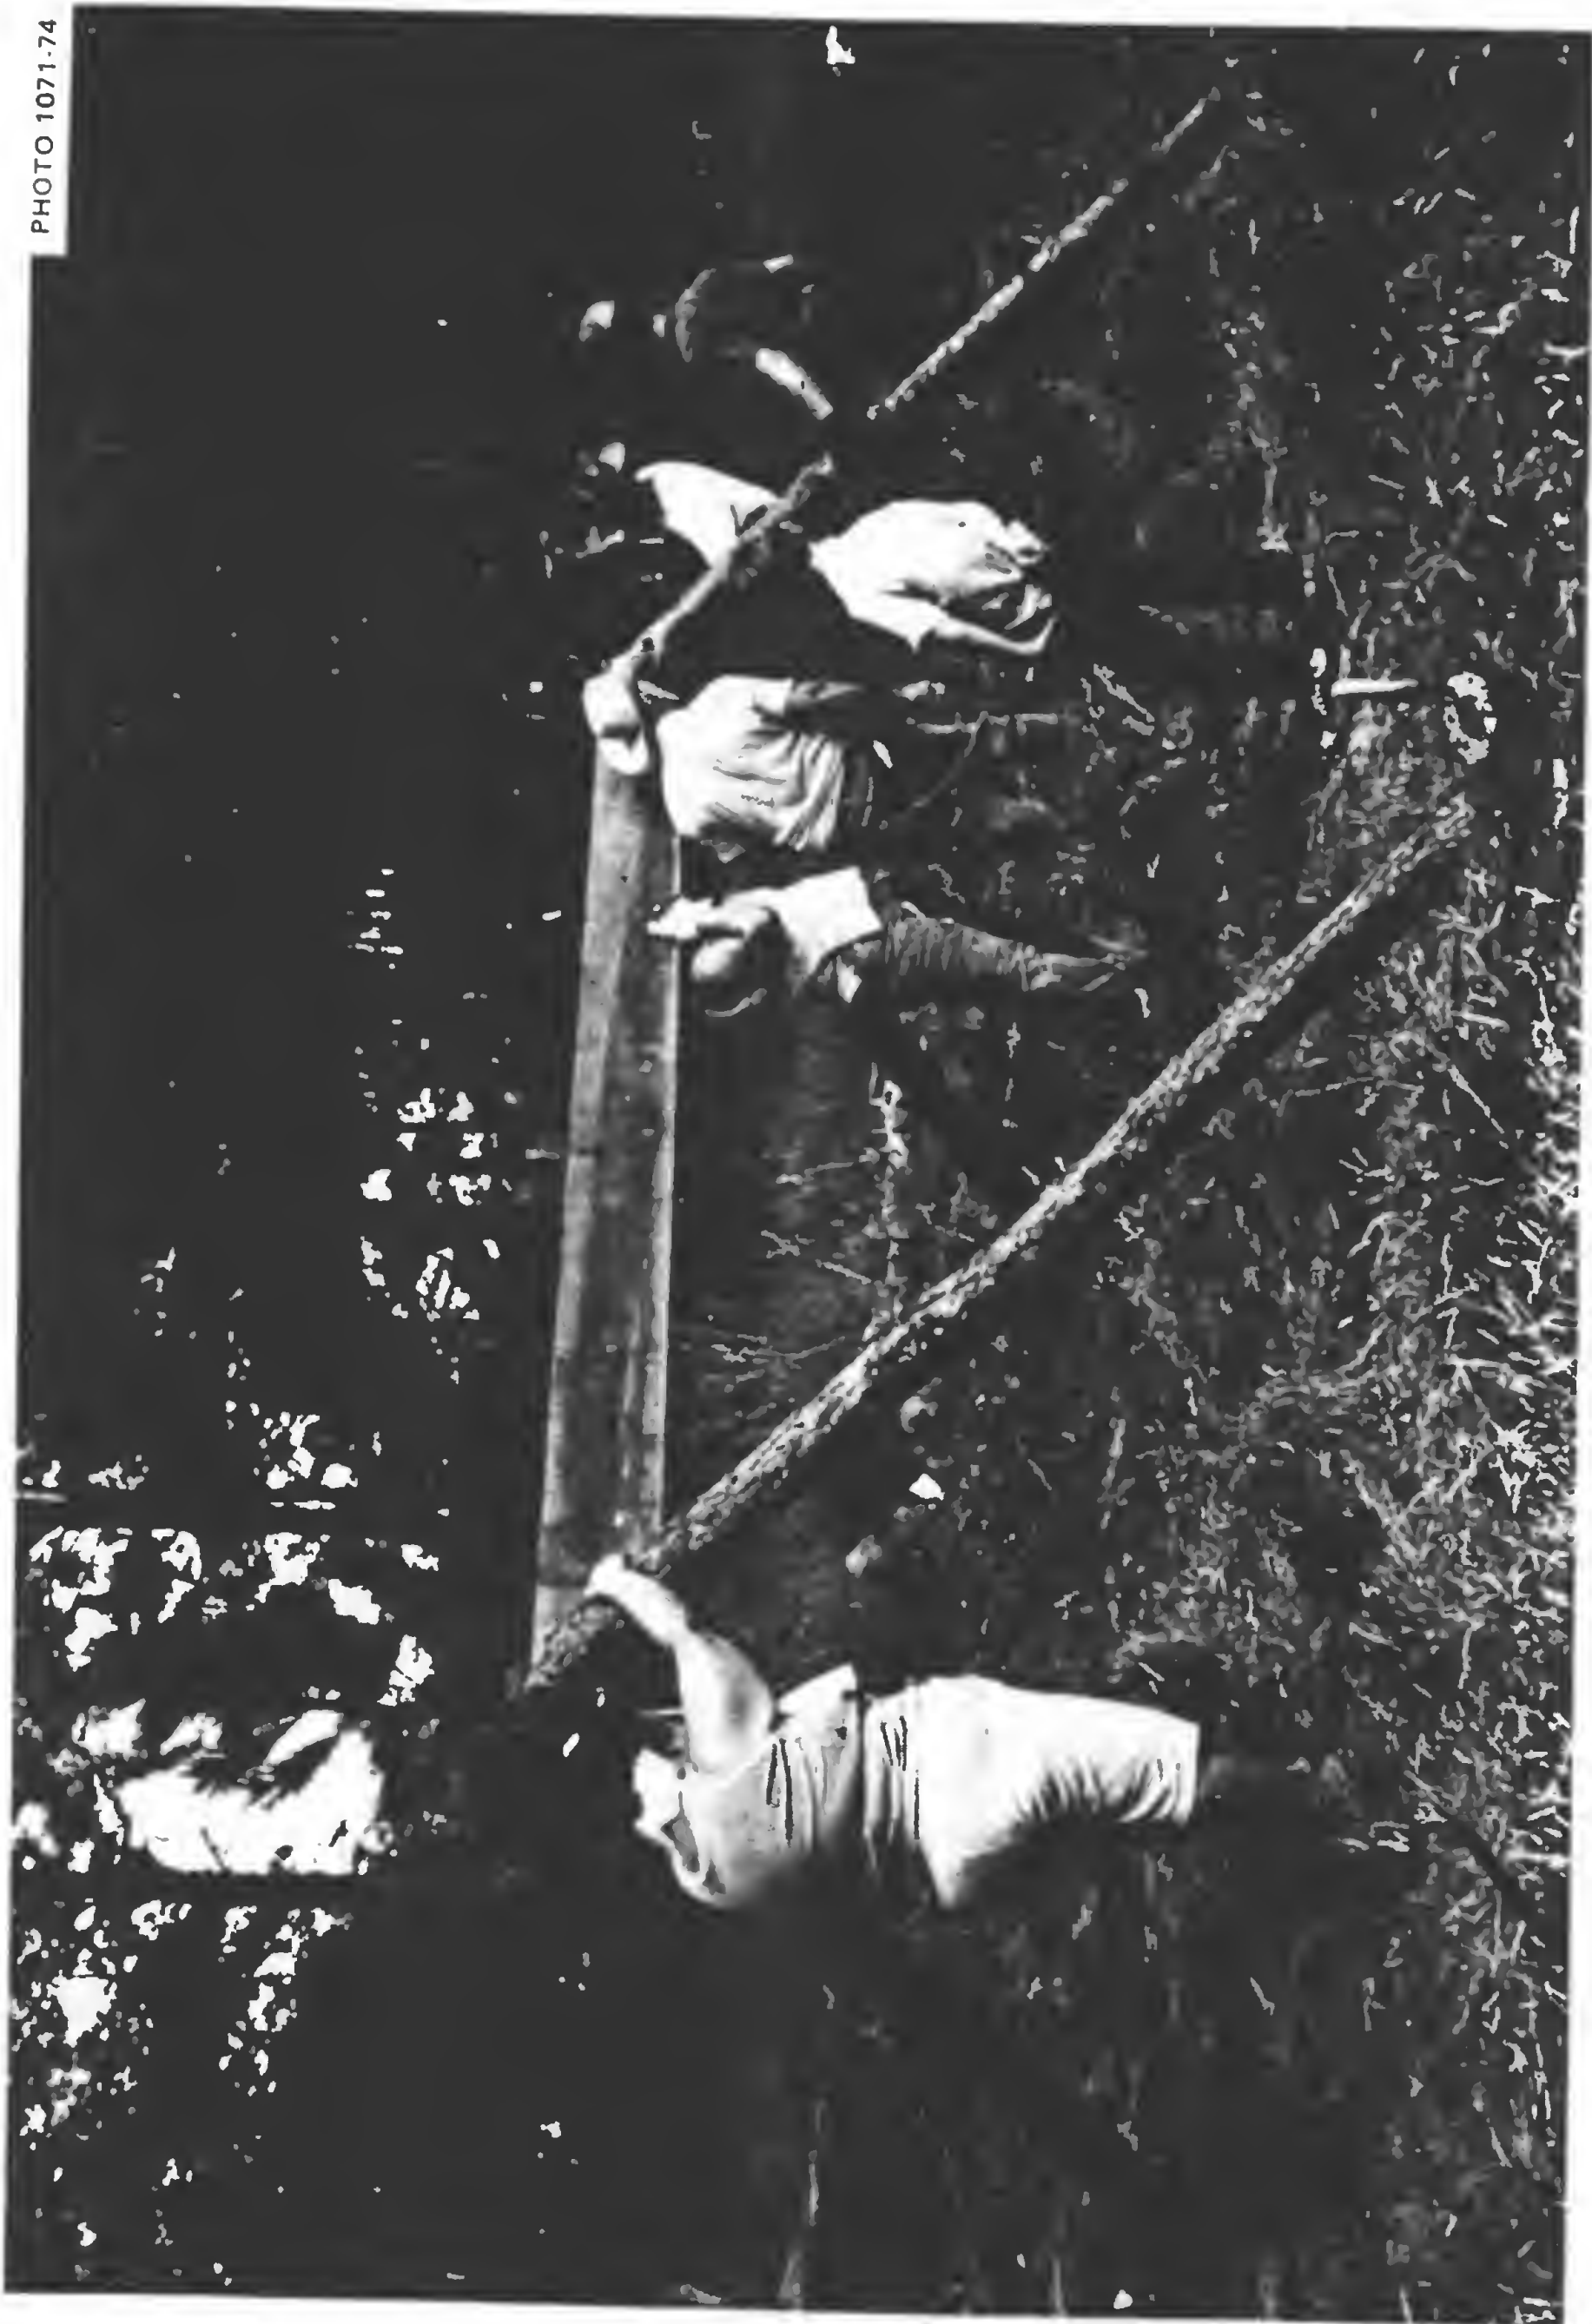
Fig. 5.44. Erecting a 16-ft-long section of the ridge board that later was extended to a 21-ft length. These decidedly competent rural people were so overconfident of their building abilities that they failed to read the instructions carefully. As a result, they made several errors that they had to correct. One of these errors was initially using a 5-in.-wide board for the first part of the ridge board; they found that the upper ends of some of the wall poles would not fit properly against a board so narrow.

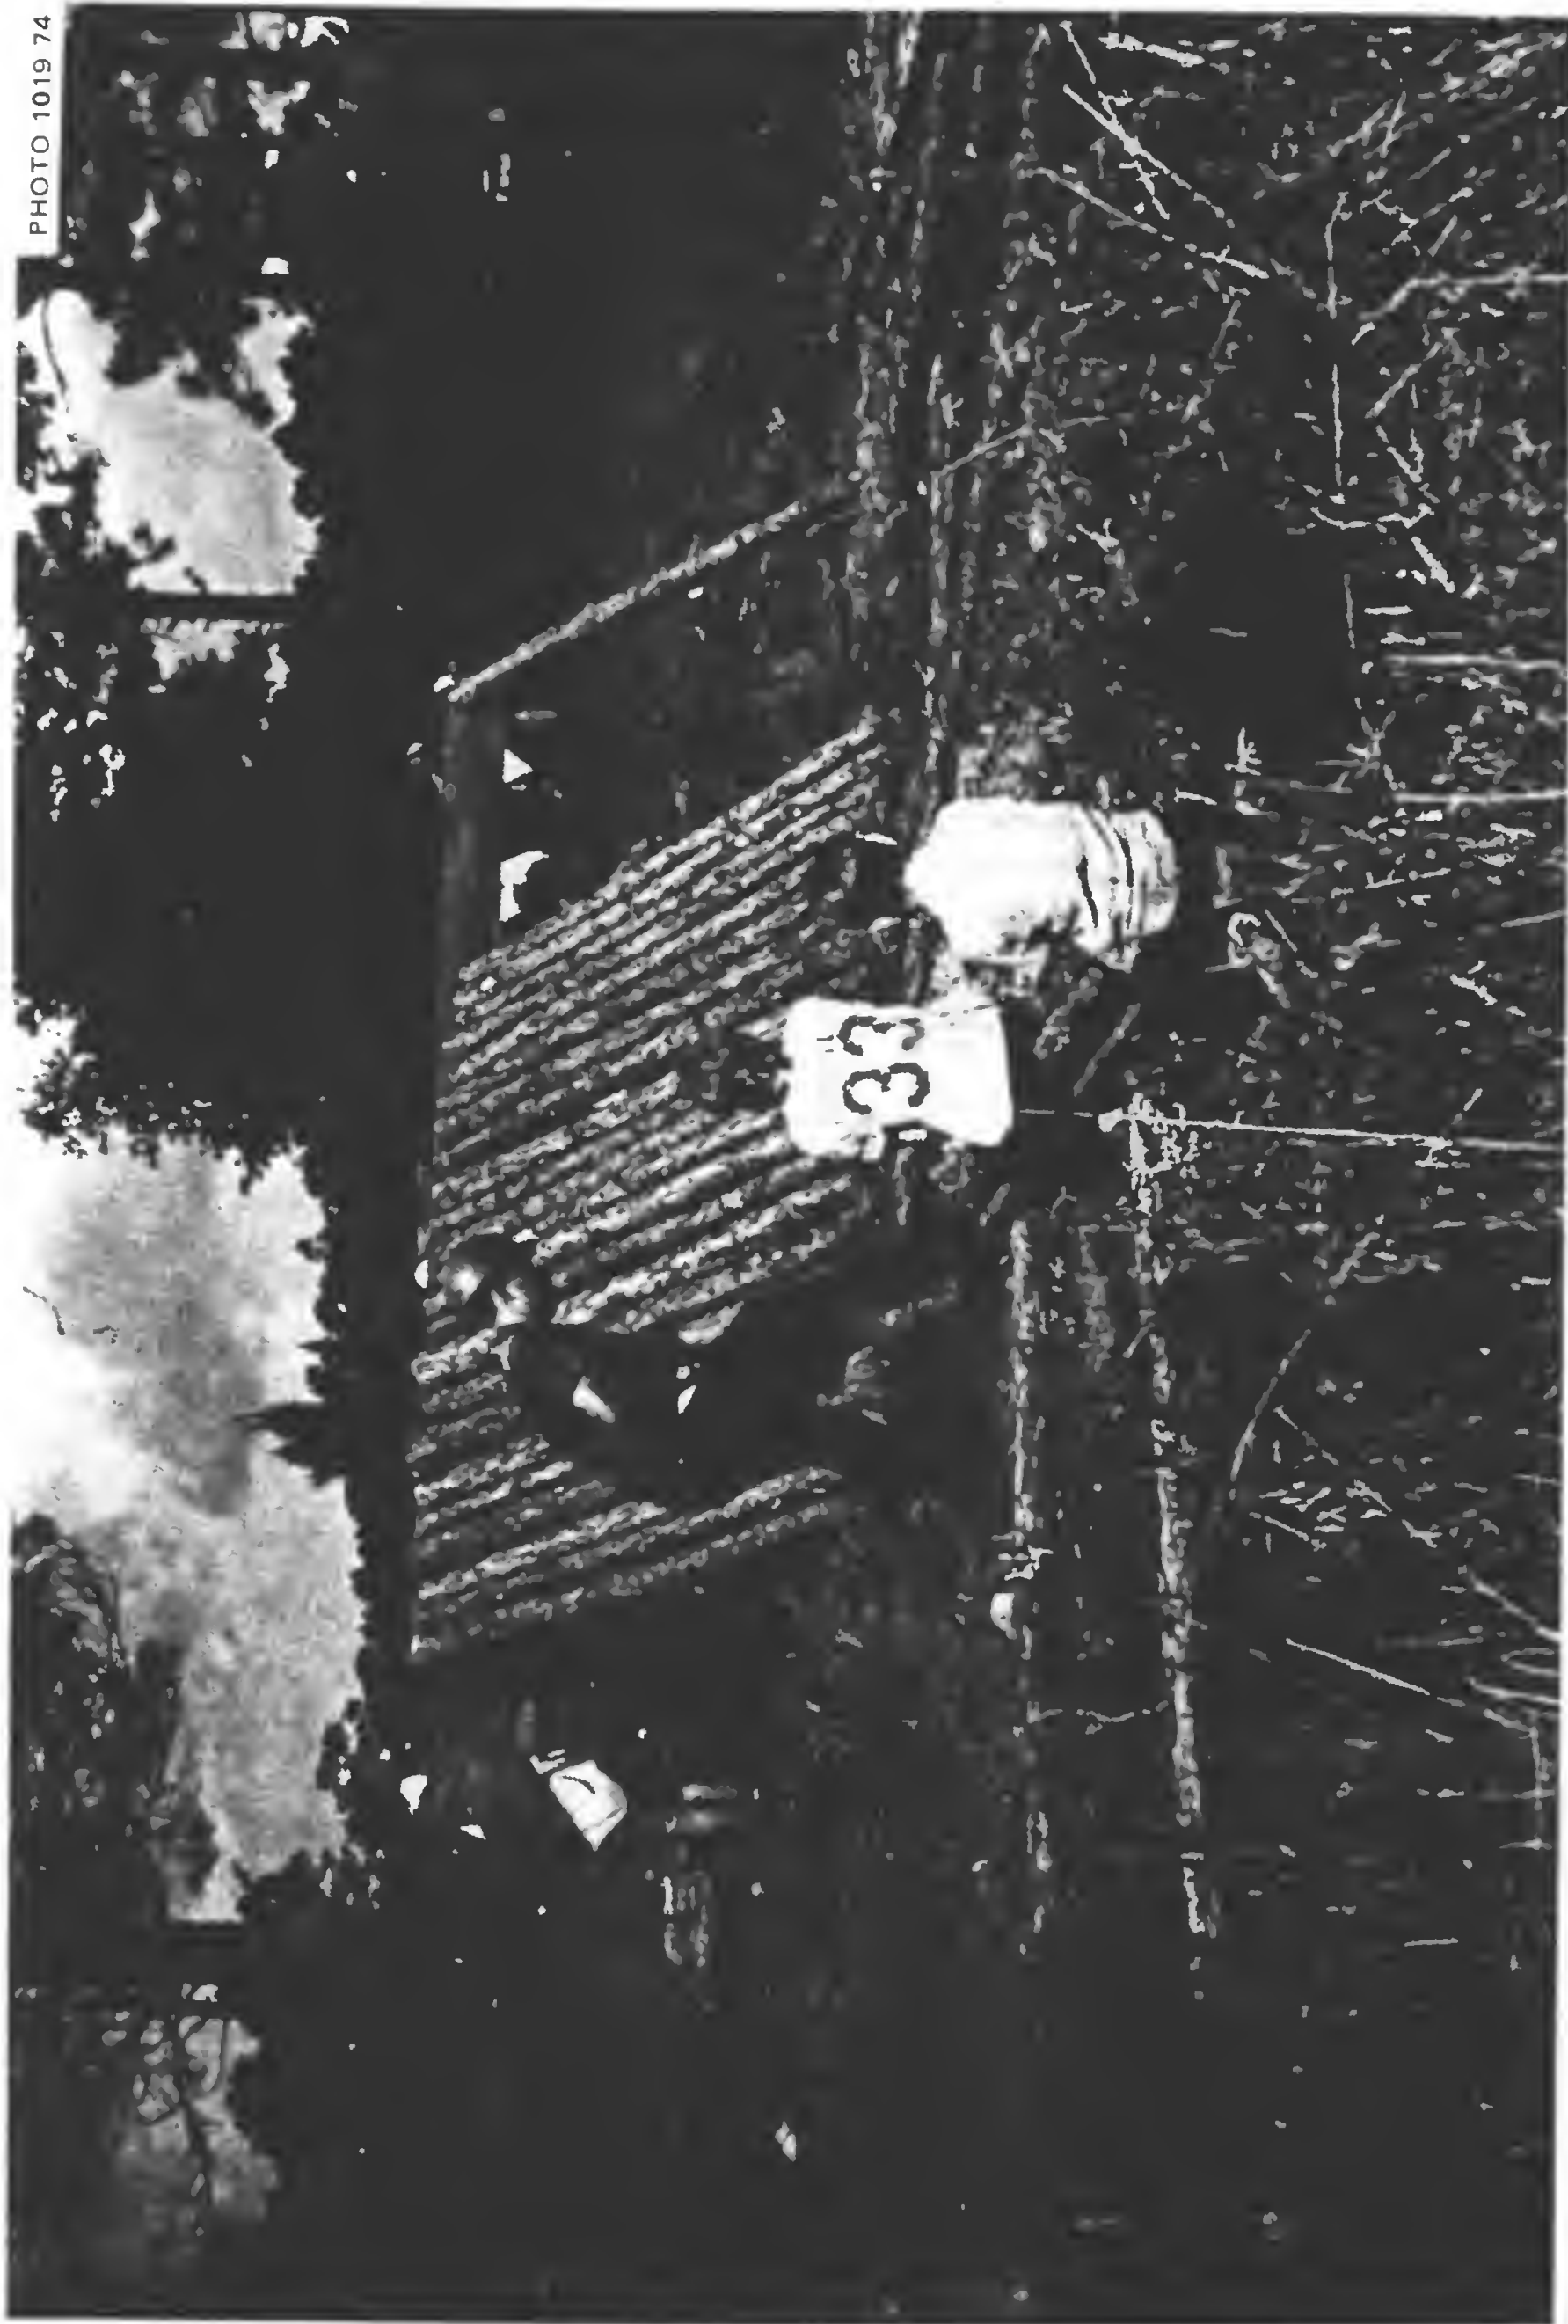
Fig. 5.45. Chain saw operator using a templet to cut an upper end of a wall pole at the specified 54° angle and 9-ft length on its short side. The templet was made from a wide 10-ft board, with one end cut at 54°. A nail was driven 9 ft from the end of this 54° angle; the squared-off base of the pole was placed against this nail.

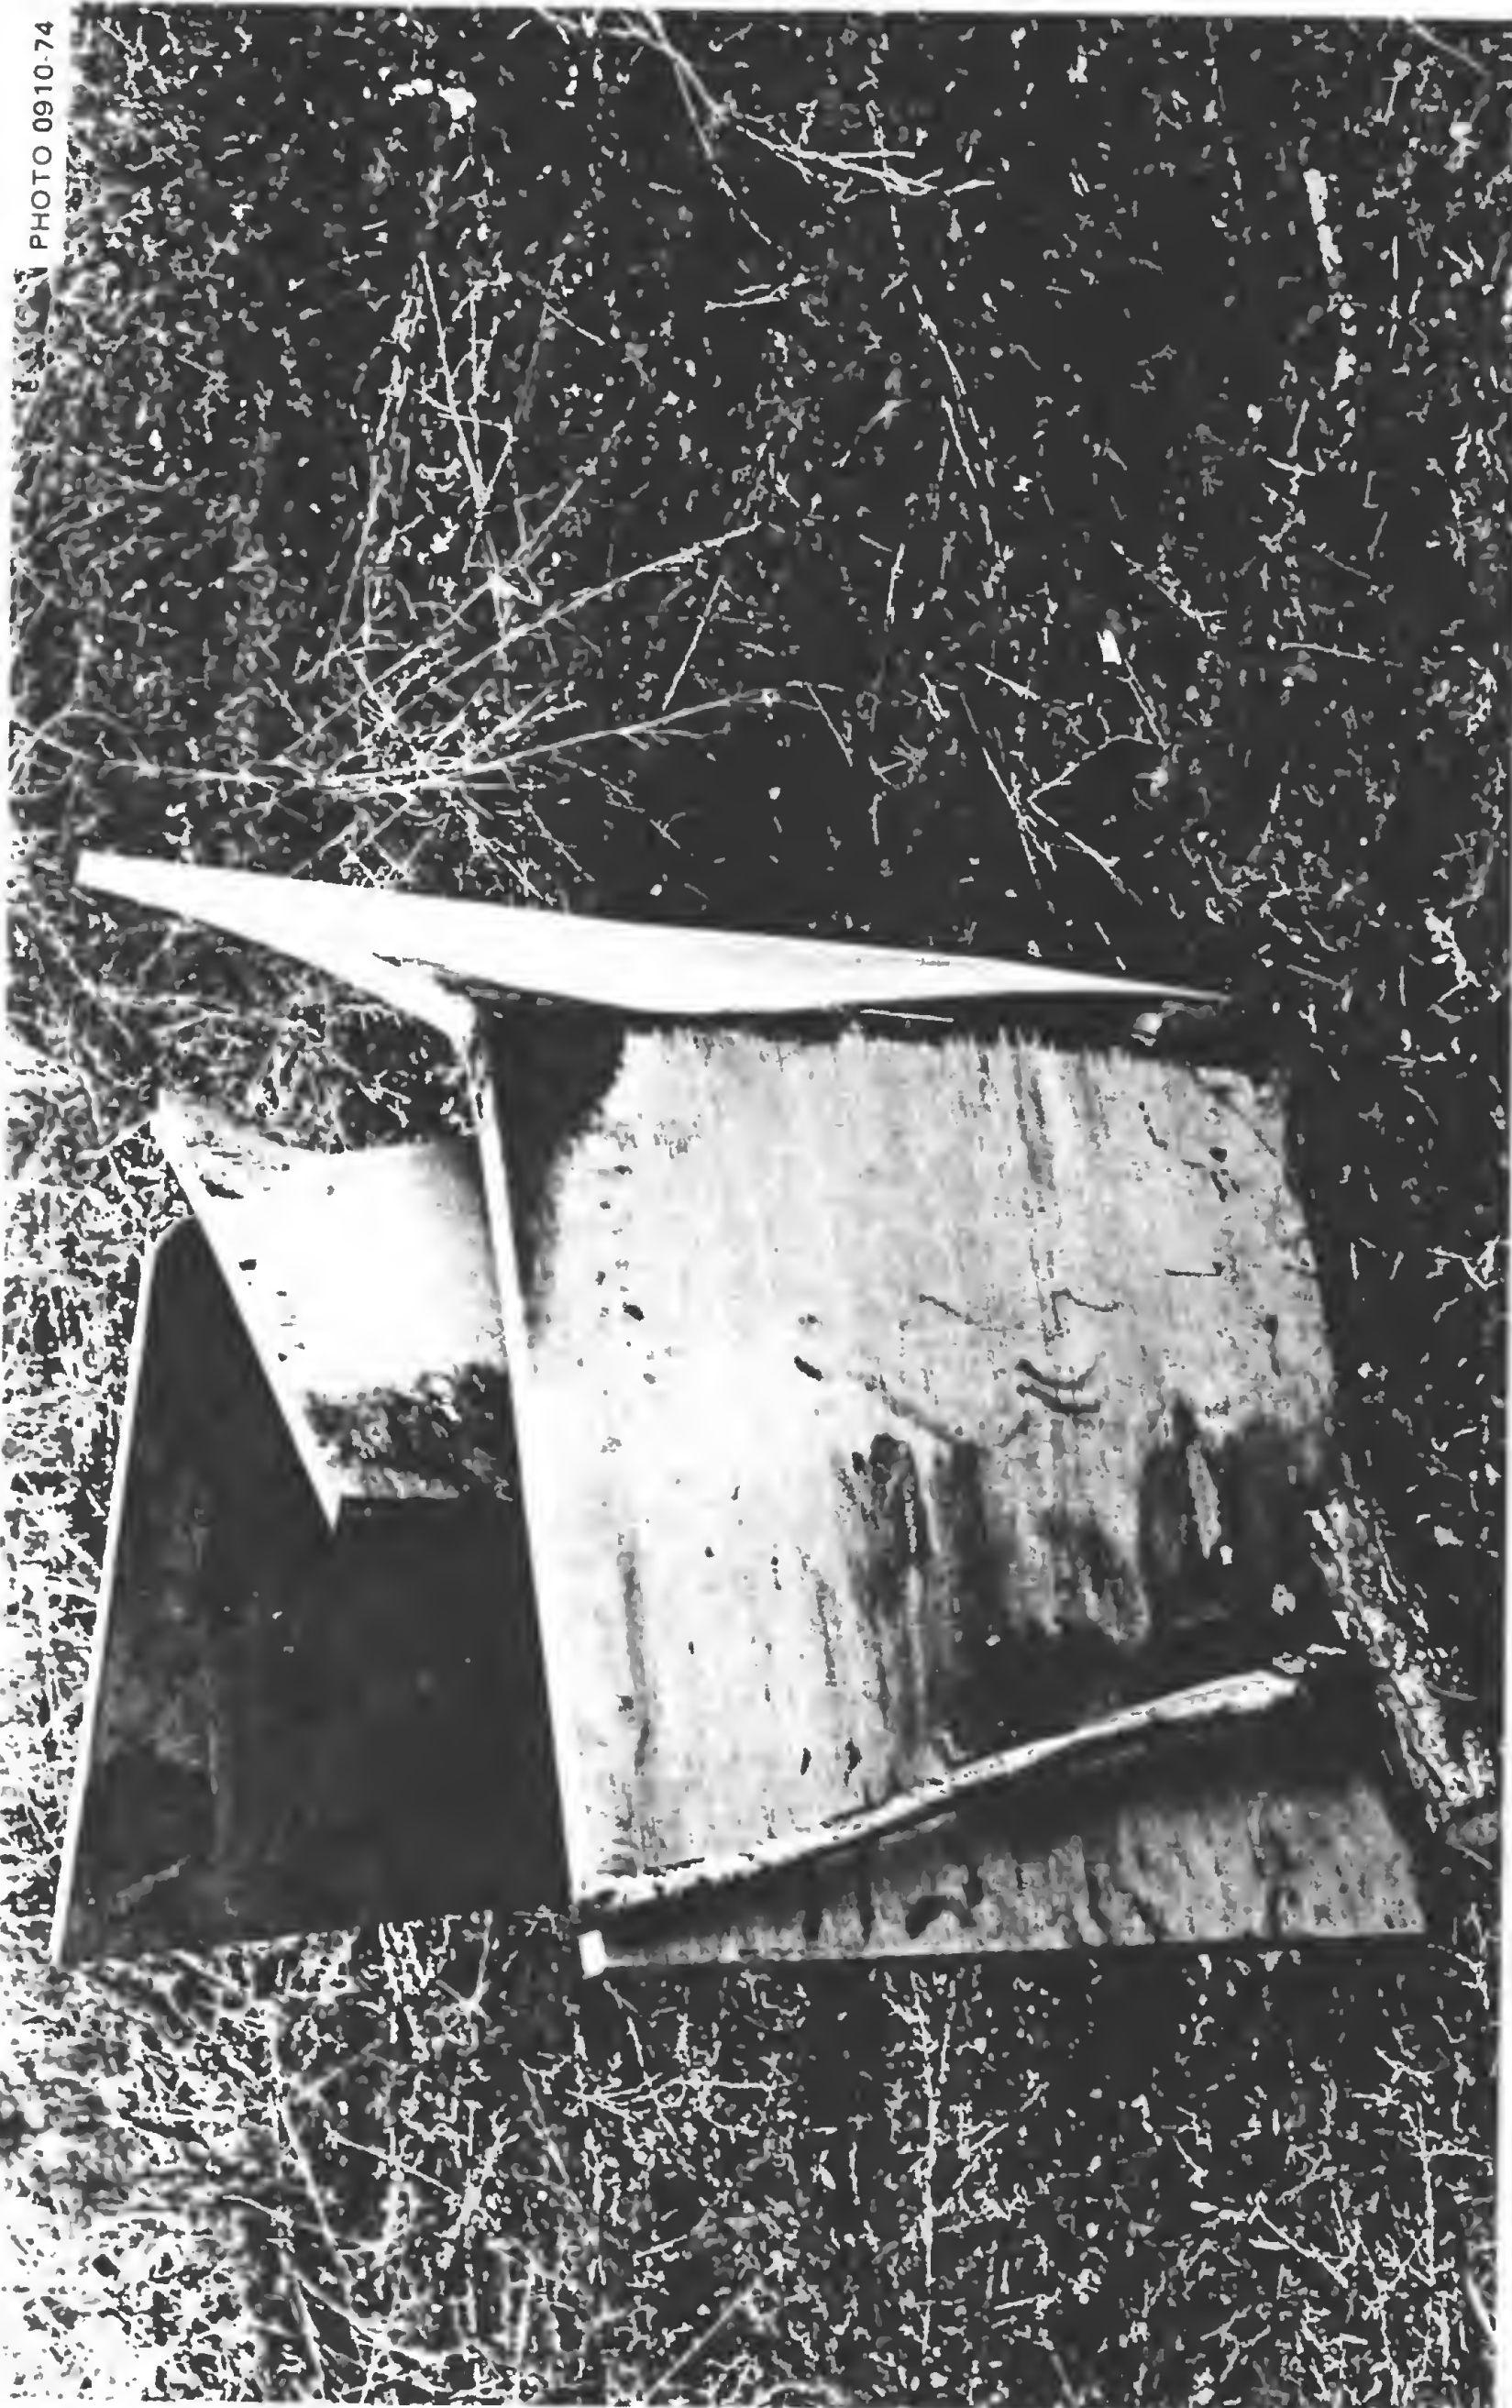
Fig. 5.56. Two of the broken roof doors after they were moved from the previously described shelter. Because the ratio of the depth of earth cover over these doors to the width of free span was too small, the centers of these broken doors fell to the floor of the shelter.
